Our ref: DE/C997/0826

### **Re: Porlock Parish Council Tree Assessment**

We visited the following parish sites on 25<sup>th</sup> August 2026:

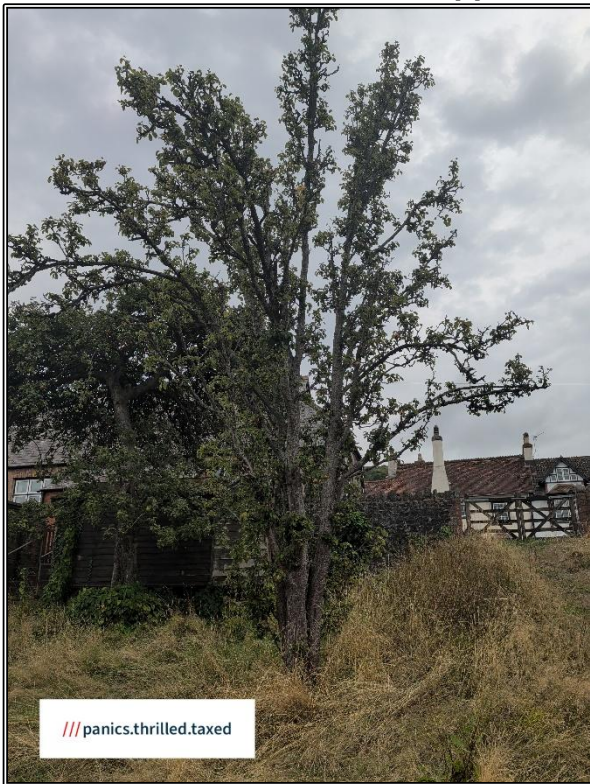
**Figure 1: Old School Centre, T1 Pear**

Pear T1 (tag 0918) has developed a tall, etiolated upper crown following a period without formative fruit-tree management. Its present form restricts practical fruit collection, although no safety-critical works are required. A staged reduction undertaken during winter dormancy would improve accessibility and gradually return the tree to a more manageable form without imposing an abrupt loss of leaf-bearing crown.

| Tree No | Species | Age Class | Ht (m) | L/E | AE | Struct Cond | Phys Cond | Comments | Haz Rate |
|---|---|---|---|---|---|---|---|---|---|
| Old School Centre<br>T1 (0918) | Pear | M | L | M | H | F | F | <ul style="list-style-type: none"> <li>Location reference: ///panics.thrilled.taxed.</li> <li>Publicly accessible orchard, but the maintained paths and no-mow areas result in low occupancy beneath the crown.</li> <li>Tall, etiolated upper crown following a period without formative fruit-tree management; fruit is not readily accessible.</li> <li>No material structural defect identified. Staged management would improve access to fruit and retain amenity value.</li> </ul> | L |

| Tree No | Species | Recommendations | WP |
|---|---|---|---|
| Old School Centre<br>T1 (0918) | Pear | <ul style="list-style-type: none"> <li>Undertake a staged crown reduction of approximately 2m, returning growth to suitable pruning points. Carry out during winter dormancy and review the need for any further reduction after 2-3 years.</li> </ul> | 5 |

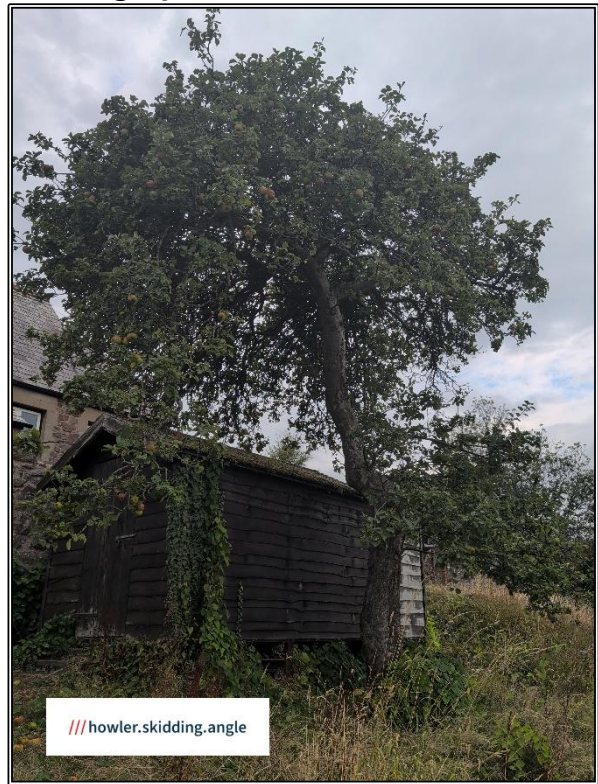
**Figure 2: Old School Centre, T2 Apple**

Apple T2 (tag 0917) has a substantial basal wound associated with removal of a former codominant stem, with decay ingress and limited occlusion. A further cavity at approximately 1 m above ground level was probed to a depth of approximately 300 mm. The stem and crown are strongly biased towards and over a small outbuilding. A light, selective reduction and thinning would reduce end-weight over the outbuilding while retaining the tree's fruiting and amenity value. The basal wound and cavity should be reassessed at the next scheduled inspection. See T1 and T2 in Appendix A and Figures 1 and 2 in Appendix C.

| Tree No | Species | Age Class | Ht (m) | L/E | AE | Struct Cond | Phys Cond | Comments | Haz Rate |
|---|---|---|---|---|---|---|---|---|---|
| Old School Centre<br>T2 (0917) | Apple | M | L | M | H | F | F | <ul style="list-style-type: none"> <li>Location reference: ///howler.skidding.angle.</li> <li>Low-occupancy public orchard; stem and crown are strongly biased towards and over a small outbuilding.</li> <li>Substantial basal wound from removal of a former codominant stem, with decay ingress and limited occlusion.</li> <li>Additional cavity at approximately 1 m above ground level; probe penetration approximately 300mm.</li> </ul> | L |

| Tree No | Species | Recommendations | WP |
|---|---|---|---|
| Old School Centre<br>T2 (0917) | Apple | <ul style="list-style-type: none"> <li>Selectively reduce and thin the crown by no more than approximately 20%, concentrating on extended growth over the outbuilding. Retain the natural crown outline and fruiting framework; undertake during winter dormancy.</li> <li>Reinspect the basal wound and cavities at the next scheduled inspection.</li> </ul> | 5<br>4 |

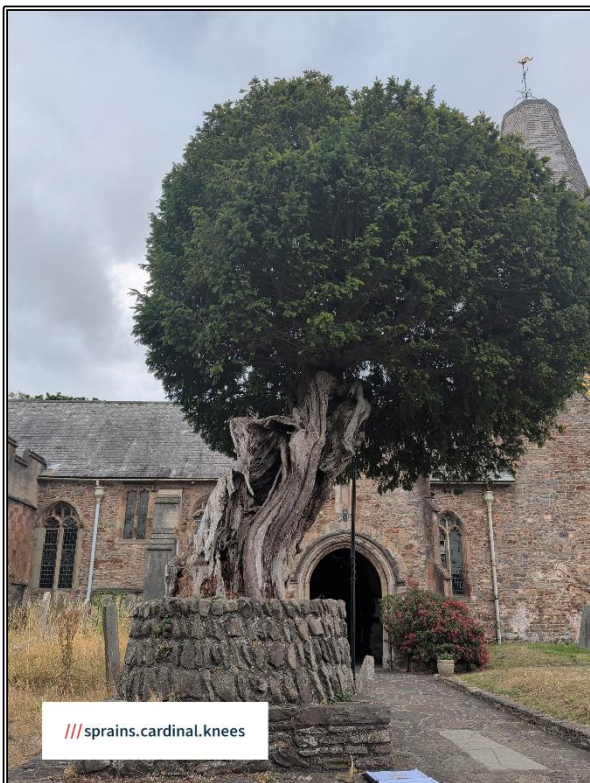
**Figure 3: St Dubricius, T3 Yew**

St Dubricius Churchyard contains an impressive veteran Yew, T3, at the frontage. The original stem is extensively hollowed and structurally degraded, with narrow strips of functional vascular tissue supporting a dense, healthy crown. A support has been installed to assist the remaining structure. Continued palliative management is appropriate: the crown should be retained in its current compact form, with vitality, functional vascular tissue and the support checked at each inspection.

| Tree No | Species | Age Class | Ht (m) | L/E | AE | Struct Cond | Phys Cond | Comments | Haz Rate |
|---|---|---|---|---|---|---|---|---|---|
| St Dubricius Church<br>T3 (no tag) | Yew | V | L | L | H | P | G | <ul style="list-style-type: none"> <li>Location reference: ///sprains.cardinal.knees.</li> <li>Veteran tree at the churchyard frontage; original stem approximately 1 m diameter and extensively hollowed/decayed.</li> <li>Narrow strips of functional vascular tissue support a dense, healthy crown.</li> <li>Support installed on the northern aspect; established frequent pruning maintains a compact crown.</li> </ul> | L |

| Tree No | Species | Recommendations | WP |
|---|---|---|---|
| St Dubricius Church<br>T3 (no tag) | Yew | <ul style="list-style-type: none"> <li>Continue the established cyclical crown management, maintaining the current compact form and avoiding any increase in crown dimensions.</li> <li>At each visit, check that the support remains correctly positioned and serviceable; monitor crown vitality and continuity of functional vascular tissue.</li> </ul> | 3<br>4 |

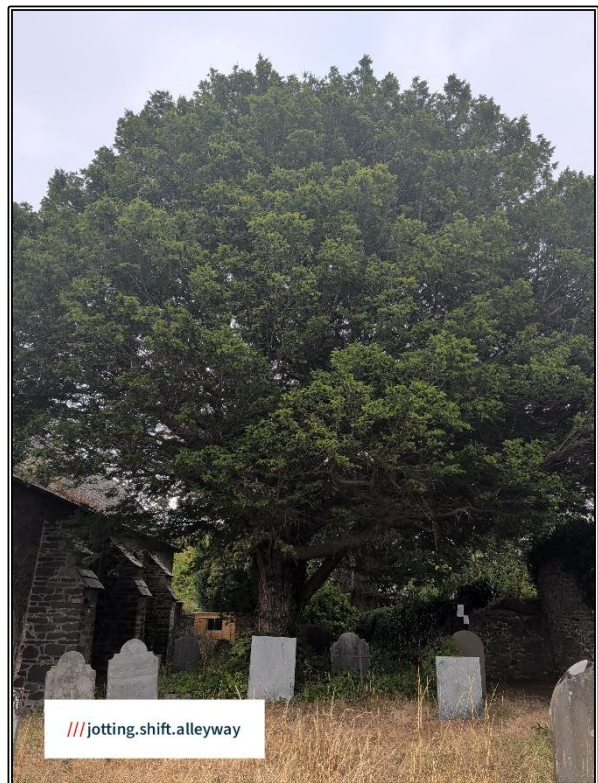
**Figure 4: St Dubricius, T4 Yew**

Mature Yew T4 stands to the rear of the churchyard and has a high target occupancy because its crown extends over graves, footpaths, walls and part of the church. The tree is in generally good condition and makes a notable contribution to local amenity. Ivy currently obscures the base and lower stem; severing and carefully removing the lower growth will facilitate future inspection of the basal union and reaction wood.

| Tree No | Species | Age Class | Ht (m) | L/E | AE | Struct Cond | Phys Cond | Comments | Haz Rate |
|---|---|---|---|---|---|---|---|---|---|
| St Dubricius Church<br>T4 (00012) | Yew | M | M | H | H | G | G | <ul style="list-style-type: none"> <li>Location reference: ///jotting.shift.alleyway.</li> <li>Prominent mature tree overhanging graves, footpaths, walls and part of the church.</li> <li>Main stem bifurcates at ground level with established reaction wood around the union.</li> <li>Ivy obscures the stem base and lower crown, limiting inspection; otherwise good visible vitality and structure.</li> </ul> | L |

| Tree No | Species | Recommendations | WP |
|---|---|---|---|
| St Dubricius Church<br>T4 (00012) | Yew | <ul style="list-style-type: none"> <li>Carefully sever Ivy at ground level and remove a minimum 300 mm section. Where practicable, remove Ivy up to approximately 2 m without damaging bark or cambium, to facilitate inspection.</li> <li>Reinspect the basal union, reaction wood and crown at the next scheduled survey due to the surrounding targets.</li> </ul> | 3<br>4 |

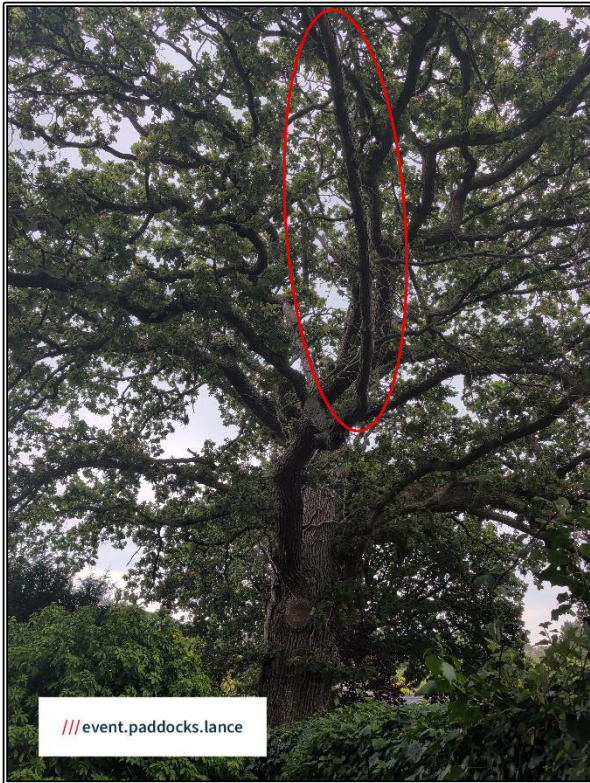
**Figure 5: St Dubricius, T5 Oak**

Oak T5 stands outside the Parish Council's managed boundary, adjacent to the school/rectory grounds, but a large wholly dead lower branch extends over the churchyard footpath. The tree appears to be naturally retrenching, with a thinning crown and scattered minor deadwood. Subject to landowner approval, the dead branch should be removed within three months. The tree's TPO status shall be confirmed with the Exmoor National Park Authority before attendance, notwithstanding the statutory exemption applying to removal of a wholly dead branch from a living tree. See T3-T5 in Appendix A and Figures 3-5 in Appendix C.

| Tree No | Species | Age Class | Ht (m) | L/E | AE | Struct Cond | Phys Cond | Comments | Haz Rate |
|---|---|---|---|---|---|---|---|---|---|
| St Dubricius Church<br>T5 (No tag) | Oak<br>(OSB/TPO) | LM | M | H | H | G | F | <ul style="list-style-type: none"> <li>Location reference: ///event.paddocks.lance.</li> <li>Significant landscape tree outside the managed boundary but within falling distance of the churchyard.</li> <li>Large wholly dead lower branch extends over the footpath.</li> <li>Crown appears to be naturally retrenching, with thinning foliage and scattered minor deadwood.</li> </ul> | M |

| Tree No | Species | Recommendations | WP |
|---|---|---|---|
| St Dubricius Church<br>T5 (No Tag) | Oak<br>(TPO) | <ul style="list-style-type: none"> <li>Subject to landowner approval, remove the large, wholly dead lower branch on the western aspect extending over the footpath.</li> <li>Confirm the tree's TPO status with the Exmoor National Park Authority before attendance. Removal of a wholly dead branch from a living tree is exempt from TPO consent and section 211 notice requirements.</li> </ul> | 2 |

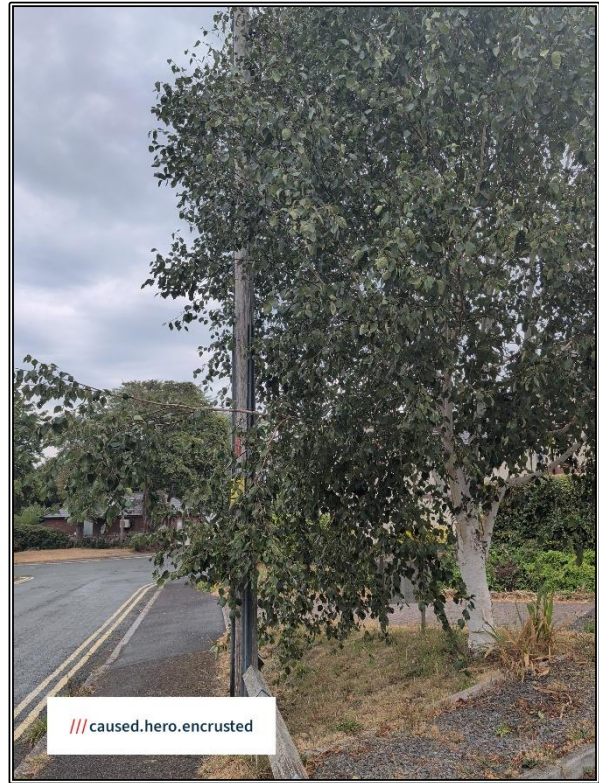
**Figure 6: High Bank carpark, T6 Birch**

Situated to the rear of Porlock Fire Station, High Bank Car Park is a small private parking area bounded by several semi-mature Paper Birch. Two trees overhang the boundary fence to the fire station but retain acceptable clearance from the building. Several crowns extend over parking spaces, although current canopy height provides adequate clearance for vehicles. Birch T6, at the entrance, has low branches encroaching over the public footway; a minor crown lift to approximately 2.5 m is recommended to maintain convenient pedestrian access. See T6 in Appendix A, the site plan in Appendix B and Figure 6 in Appendix C.

| Tree No | Species | Age Class | Ht (m) | L/E | AE | Struct Cond | Phys Cond | Comments | Haz Rate |
|---|---|---|---|---|---|---|---|---|---|
| High Bank Car Park<br>T6 (No tag) | Birch | M | M | M | M | G | G | <ul style="list-style-type: none"> <li>Location reference: ///caused.hero.encrusted.</li> <li>Located beside the car park entrance.</li> <li>Low branches on the northern aspect encroach over the public footway; otherwise good visible condition.</li> </ul> | L |

| Tree No | Species | Recommendations | WP |
|---|---|---|---|
| High Bank Car Park<br>T6 (No tag) | Birch | <ul style="list-style-type: none"> <li>Crown lift the lowest branches on the northern aspect to suitable pruning points, providing approximately 2.5 m clearance over the footway while retaining a balanced crown.</li> </ul> | 3 |

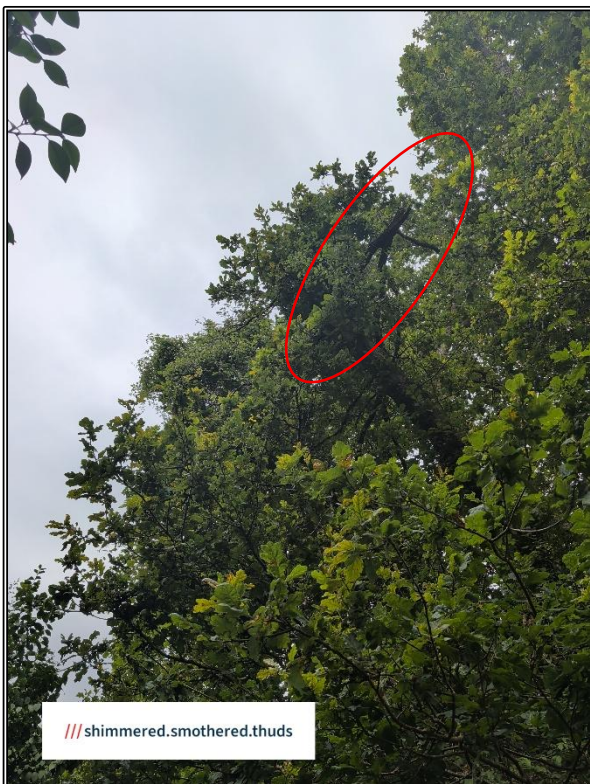
**Figure 7: Zig-Zag Path, T7 Oak**

Zig-Zag Path is a steep pedestrian route descending from the unnamed road east of the site to the level field south of the tennis courts. The path passes beneath a mixed canopy of mature Oak, Scots Pine and Ash, with Elder and Hazel beneath. At the top of the path, Oak T7 has a snapped dead branch lodged in the crown at approximately 6 m, above the road and pedestrian access. Although the branch appears relatively secure, dislodgement cannot be ruled out and removal within three months is recommended. Approximately halfway down the path, Ash T8 is affected by ADD at Class 3 of 4. Its elongated form and limited anchor points are

| Tree No | Species | Age Class | Ht (m) | L/E | AE | Struct Cond | Phys Cond | Comments | Haz Rate |
|---|---|---|---|---|---|---|---|---|---|
| Zig-Zag Path<br>T7 (No tag) | Oak | M | H | H | H | F | F | <ul style="list-style-type: none"> <li>Location reference: ///shimmered.smothered.thuds.</li> <li>Snapped dead branch lodged in the crown at approximately 6 m above the road and footpath.</li> <li>The branch appears relatively secure, but dislodgement cannot be ruled out.</li> <li>Remaining visible crown form and vitality are satisfactory for the wooded setting; no other material defect identified.</li> </ul> | M |

| Tree No | Species | Recommendations | WP |
|---|---|---|---|
| Zig-Zag Path<br>T7 (No Tag) | Oak | <ul style="list-style-type: none"> <li>Remove the snapped, hung-up dead branch at approximately 6 m above the road and footpath. Avoid unnecessary pruning of the supporting live crown.</li> </ul> | 2 |

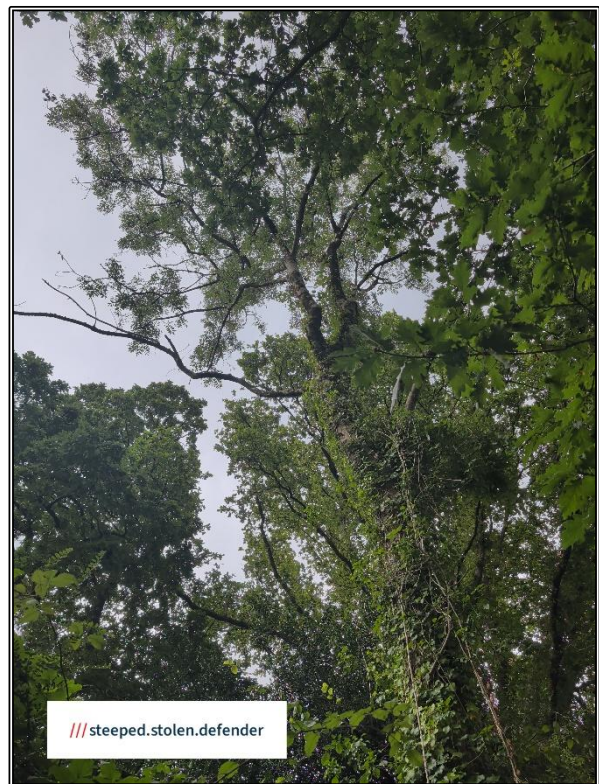
**Figure 8: Zig-Zag Path, T8 Ash**

likely to make safe climbing and rigging more difficult as decline progresses. The tree has therefore been marked for substantial reduction to a habitat pole while access and condition remain favourable. See T7 and T8 in Appendix A and Figures 7 and 8 in Appendix C.

| Tree No | Species | Age Class | Ht (m) | L/E | AE | Struct Cond | Phys Cond | Comments | Haz Rate |
|---|---|---|---|---|---|---|---|---|---|
| Zig-Zag Path<br><br>T8<br>(Sprayed) | Ash | M | M | S | M | F | P | <ul style="list-style-type: none"> <li>Location reference: ///steeped.stolen.defender.</li> <li>Located approximately halfway down the northern side of the path.</li> <li>ADD Class 3 of 4, with crown thinning and development of minor and major deadwood.</li> <li>Elongated form and limited anchor points are likely to make safe climbing and rigging more difficult as decline progresses.</li> </ul> | M |

| Tree No | Species | Recommendations | WP |
|---|---|---|---|
| Zig-Zag Path<br>T8 (Sprayed) | Ash | <ul style="list-style-type: none"> <li>Dismantle to a monolith/habitat pole approximately 4 m high while tree condition and access still allow safe climbing and rigging. Retain habitat features where it is safe to do so.</li> </ul> | 3 |

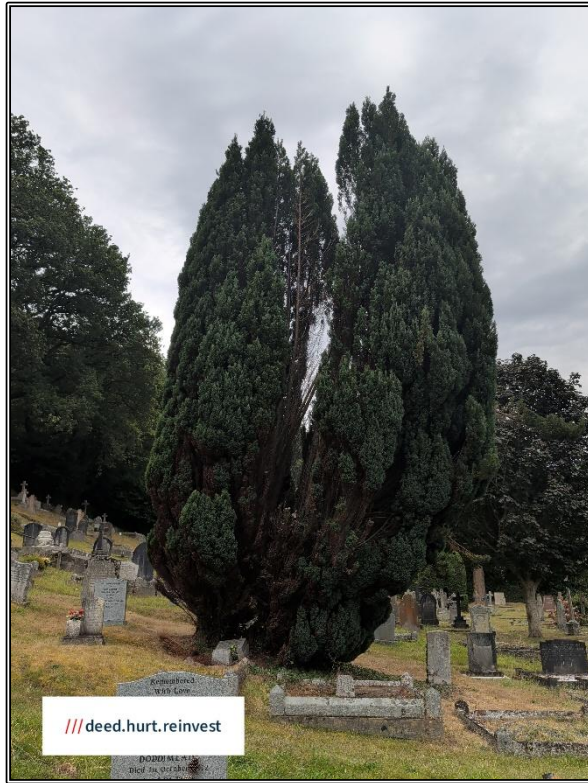
**Figure 9: War Memorial Cemetery, T9 Irish Yew**

Irish Yew T9 presents as two closely spaced stems or trees whose crowns are progressively separating. No above-ground union, cracking, splitting or root-plate movement was evident. Crown separation is approximately 500 mm at the upper canopy and reduces towards ground level. Given the tree's modest stature and the site's low occupancy, the foreseeable consequence of failure is low and removal is not considered safety critical. Static or dynamic bracing was considered, but the uncertainty of below ground conditions, limitations for future inspection and potential limited remaining life expectancy make controlled removal and replacement the more sustainable long-term option.

| Tree No | Species | Age Class | Ht (m) | L/E | AE | Struct Cond | Phys Cond | Comments | Haz Rate |
|---|---|---|---|---|---|---|---|---|---|
| Porlock Cemetary<br><br>T9 (No tag) | Irish Yew | M | L | L | H | F | F | <ul style="list-style-type: none"> <li>Location reference: ///deed.hurt.reinvest.</li> <li>Noteworthy central tree in a low-occupancy burial ground.</li> <li>Appears to comprise two closely planted trees or a bifurcation below ground level; no above-ground union, cracking, splitting or root-plate movement observed.</li> <li>Crowns are separated by approximately 500 mm at their upper extent, reducing towards ground level. Removal and replacement are advisory rather than safety-critical.</li> </ul> | L |

We recommend removal of T9 as a WP5 advisory action and replacement during the next available planting season with three standard Common Yews. The stumps may be cut close to ground level; some gradual settlement can be expected as the residual woody material decays. Stump grinding or excavation and backfilling would be disproportionately invasive in the burial ground and is not recommended unless required for future grave management. See T9 in Appendix A and Figure 9 in Appendix C.

| Tree No | Species | Recommendations | WP |
|---|---|---|---|
| Porlock Cemetery<br>T9 (No Tag) | Irish Yew | <ul style="list-style-type: none"> <li>Remove following submission of a section 211 notice. This is an advisory, non-safety-critical recommendation made because of progressive loss of crown cohesion and limited long-term management options.</li> <li>Replant during the next available planting season with three standard Common Yews (<i>Taxus baccata</i>), spaced to allow independent crown development. Provide watering, weed control and establishment maintenance until established.</li> </ul> | 5<br>5 |
